# Quaternary Geology and Landslide Dam Hazard Assessment of the Shotover Gorge, Otago

A thesis submitted in partial fulfilment  
of the requirements for the degree of

**Master of Science**  
**in Disaster, Risk and Resilience**

at the  
University of Canterbury

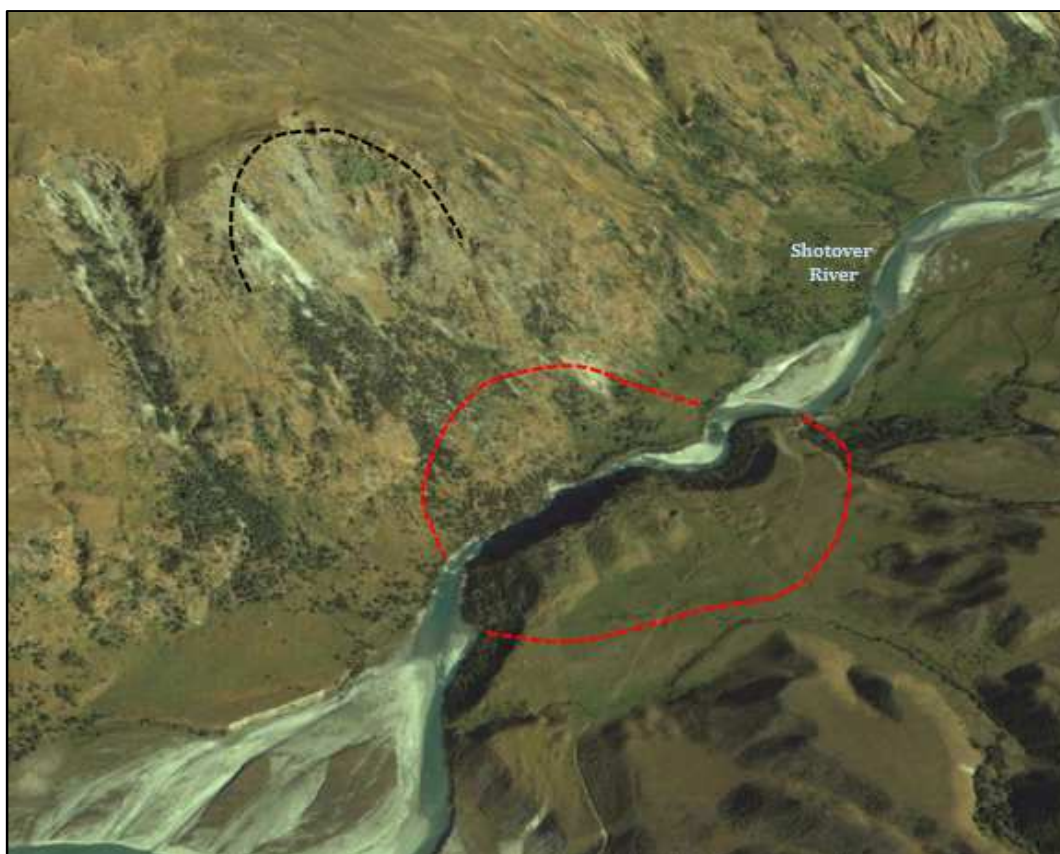
**Figure 8:** Shotover River landslide dam at Saddle Creek, showing landslide deposit and incised river channel.

This landslide is sourced from a scarp to the west of the Shotover River, shortly upstream from the Shiel Burn confluence. Debris has runout for a distance of about 400 m length from the base of the scarp. The river has incised deeply into landslide debris, forming a narrow gorge about 400 m in length. The river forms rapids through this section, with a surveyed elevation change of about 10 m (McSaveney 1978, Figure 7). There are a number of large alluvial terraces in this area. The landslide deposit may post-date and be emplaced onto alluvial terraces, or these terrace gravels may be younger, and have aggraded around and partially covered this landslide deposit.

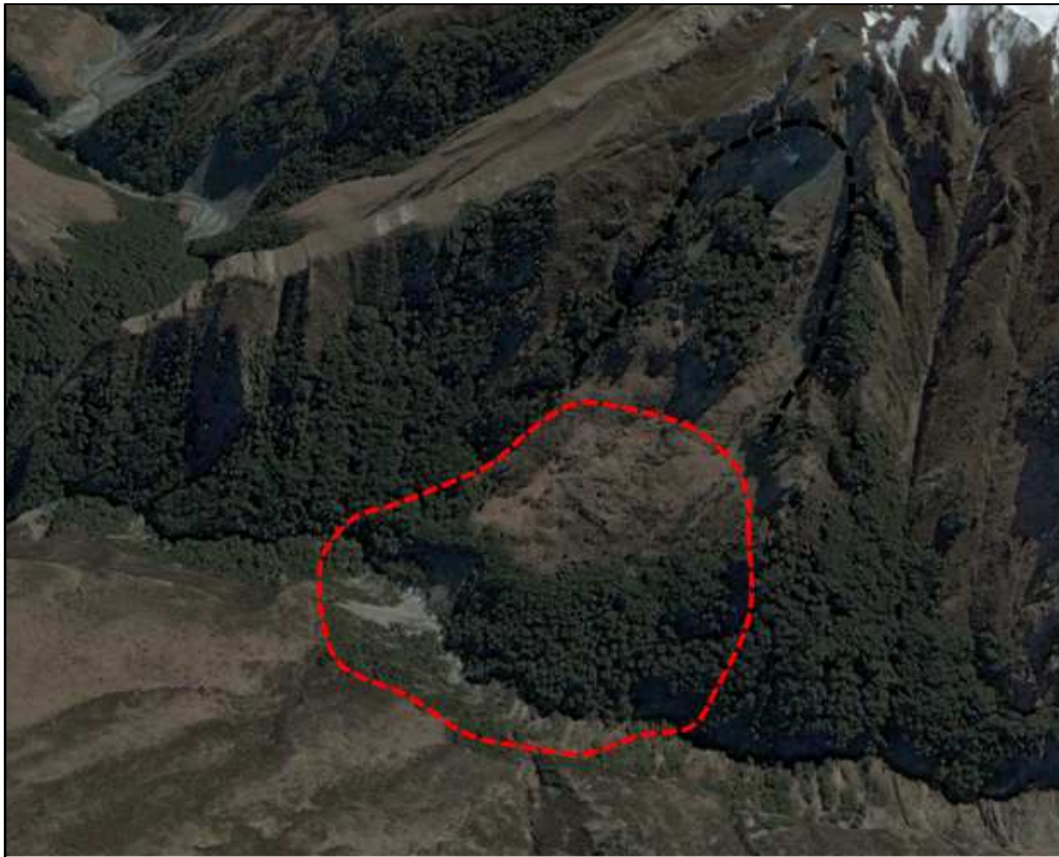
**Figure 9:** Stony Creek landslide dam.

This is interpreted to be the landslide referred to by the OCB (1966) - *“the lower reaches of this creek are deeply entrenched in a gorge which, because of a large debris avalanche in its upper portion, does not provide convenient access to the upper valley.”* Although mostly obscured by vegetation, it appears the creek has incised a deep gorge through the landslide debris. The lower portion of the slope shows a hummocky texture with many large boulders up to ~10 m visible.

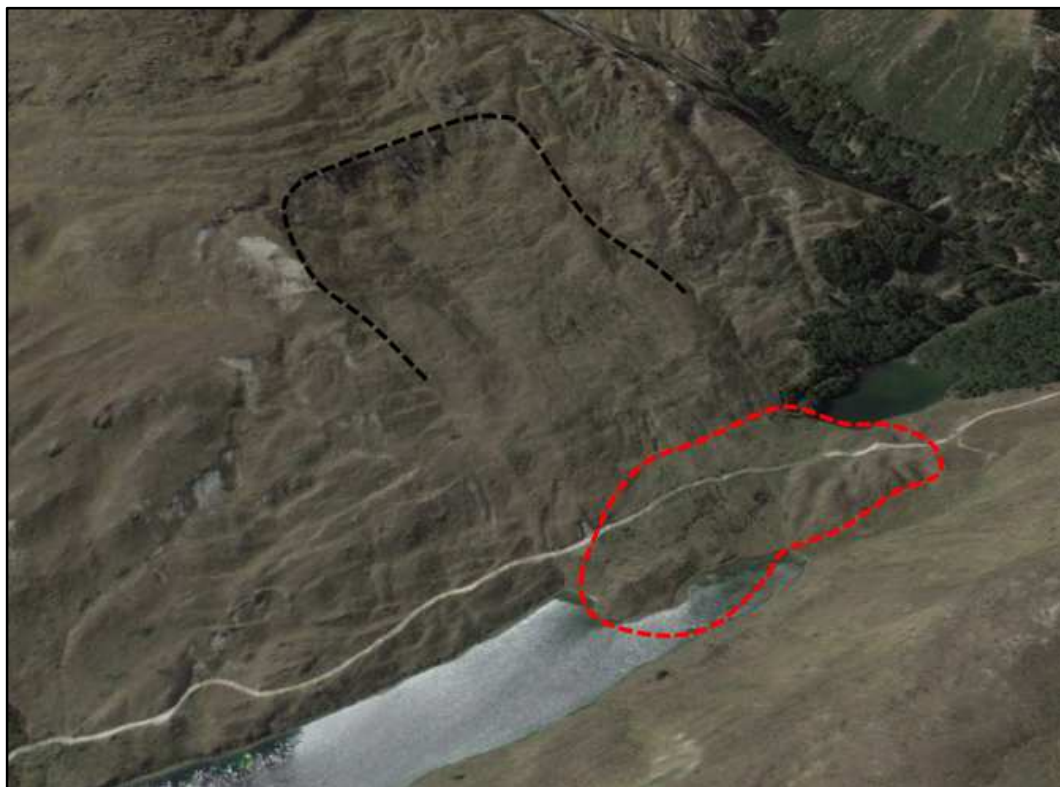
**Figure 10:** The interpreted Lake Luna rock avalanche at the southern end of Lake Luna. To the right of the landslide deposit is another small lake – Dukes Tarn.

Interpreted by McSaveney (1978) as a small rock avalanche, blocking the south end of Lake Luna. This landslide may have led to the capture of ~8 km<sup>2</sup> of 25 Mile Creek, which now drains into Luna Creek and the Moonlight catchment (McSaveney 1978).

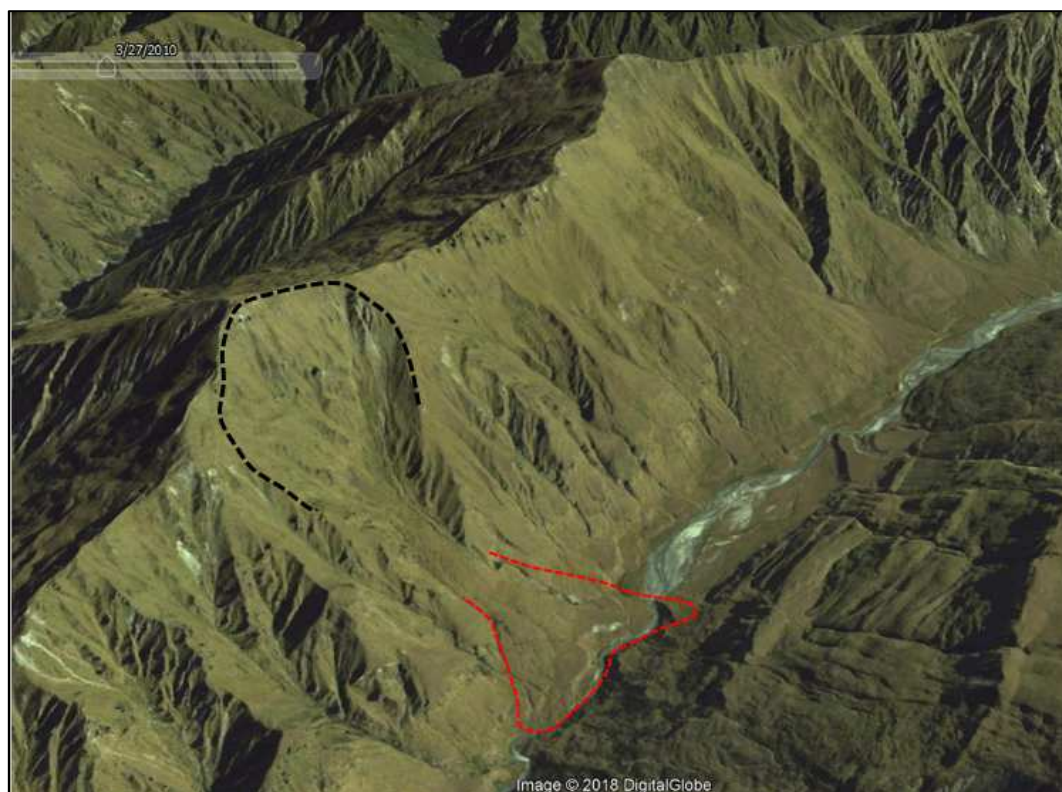
There are several large landslides in the Polnoon valley downstream of the main Polnoon Burn landslide dam. The slide with the most distinct interaction with the channel is shown below. The riverbed is strongly aggraded for several km upstream from landslide, suggesting a significant blockage. Creek has incised a channel through debris at toe of slide. Common channel margin terraces may show remains of a higher aggradation surface, now incised. A larger landslide shortly upstream appears to have reached the valley floor but not formed a landslide dam.

**Figure 11:** Possible landslide dam in the lower Polnoon Burn.

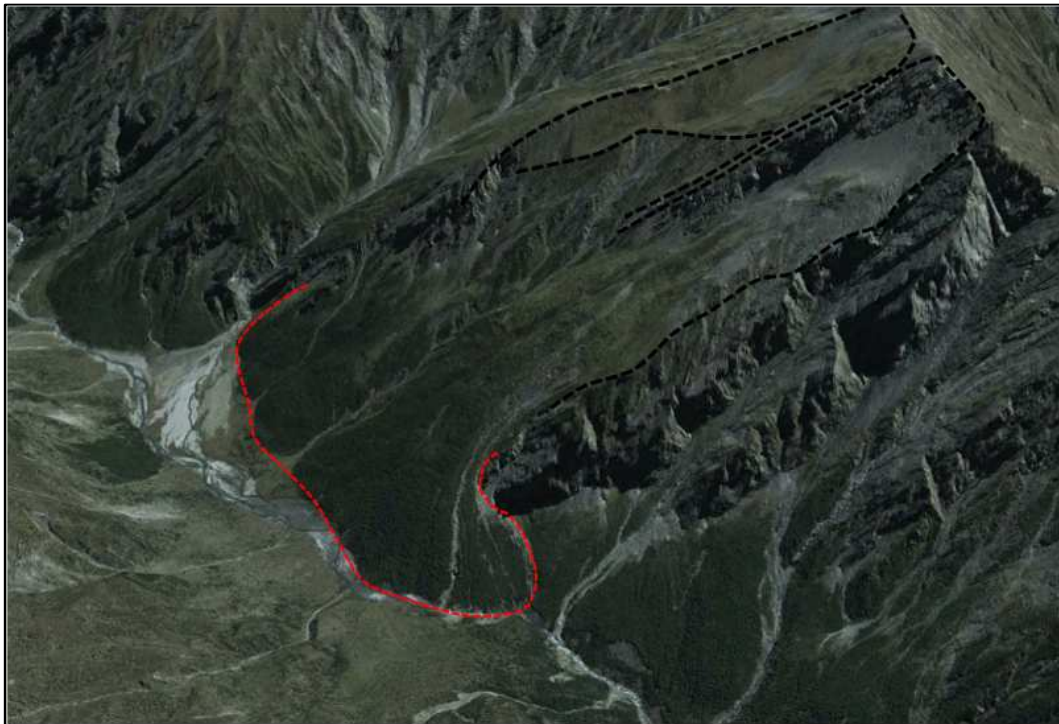
This may be one single large landslide or two adjacent landslides with a combined width of ~600 m, and total volume estimated at 10-20M m<sup>3</sup>. The creek forms a rapid where it cuts through the toe of the landslide debris. Upstream the valley is sediment infilled for >1 km, and a large alluvial fan is formed from an unnamed northern tributary.

**Figure 12:** Possible landslide dam in Sixteen Mile Creek.

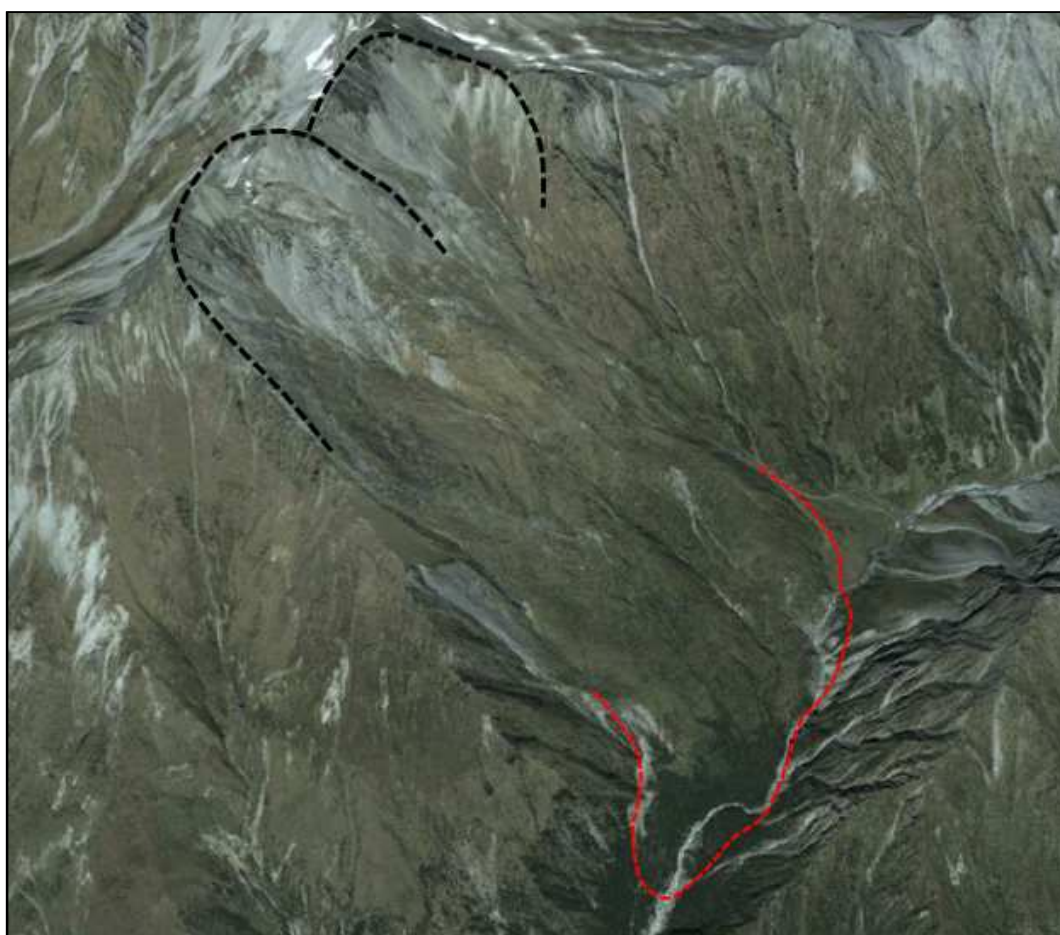
In the left-hand branch of Sixteen Mile Creek (Robertson Creek), a very large landslide blocks the creek around 900 m upstream from the junction of the left and right branches. This is probably that described by Willett (1939): *“Two huge landslides block the mouth of the glacial valley and over them the stream cascades to the junction some 700 ft below”*. This landslide is ~800 m in width, and may have a volume of several tens of millions of cubic metres. A smaller landslide deposit from the opposite (northern slopes) also appears to contribute to dam formation.

The alluvial flats upstream are at an elevation of about 1160 m, and landslide debris appears to extend downstream to an elevation of <900 m. This indicates the possible formation of a very large landslide dam, although in a relatively small, steep gradient catchment, there would have been little potential for formation of a significant reservoir.

**Figure 13:** A very large, and potentially dam-forming landslide in Robertson Creek.

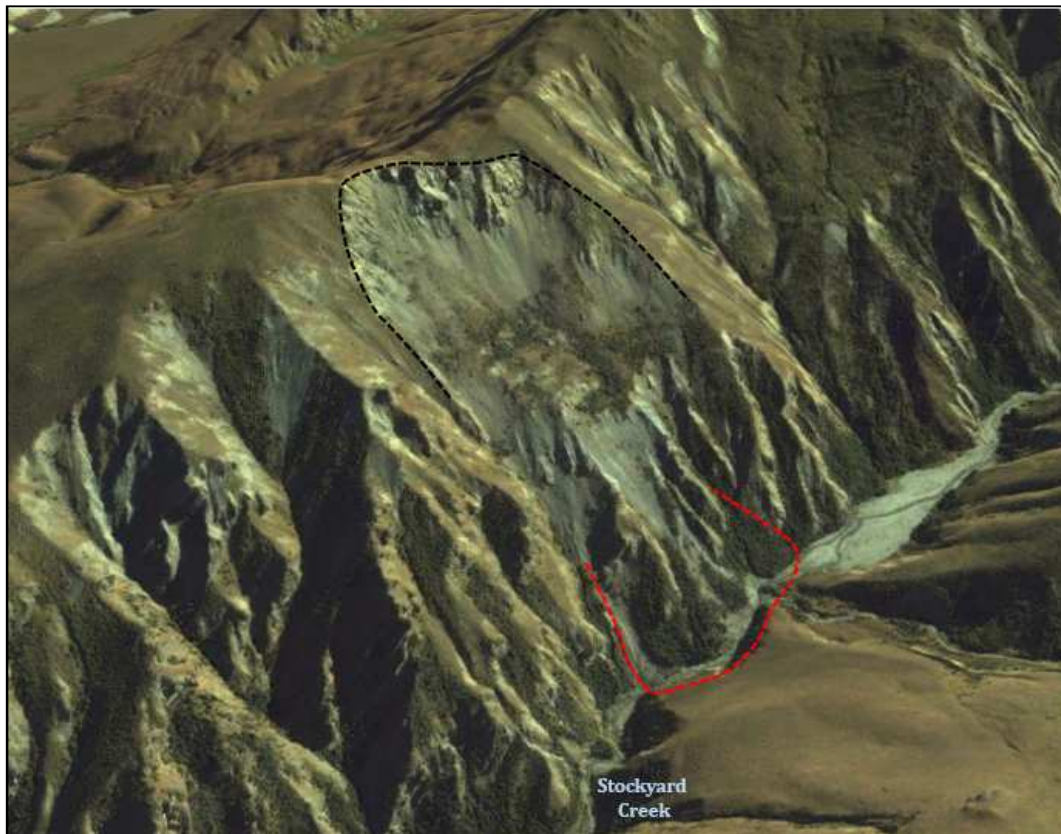
This landslide is located at about 2 km up Stockyard Creek from Branches Flat. The landslide has width of >500 m and estimated volume of  $\sim 1\text{M m}^3$ . The creek has been pushed to the far side of the valley by the slide, and forms a section of rapids through this part. For about 400 m upstream of the dam is a broad sediment-infilled channel up to 50 m in width.

**Figure 15:** Dam-forming landslide in the lower reaches of Stockyard Creek.

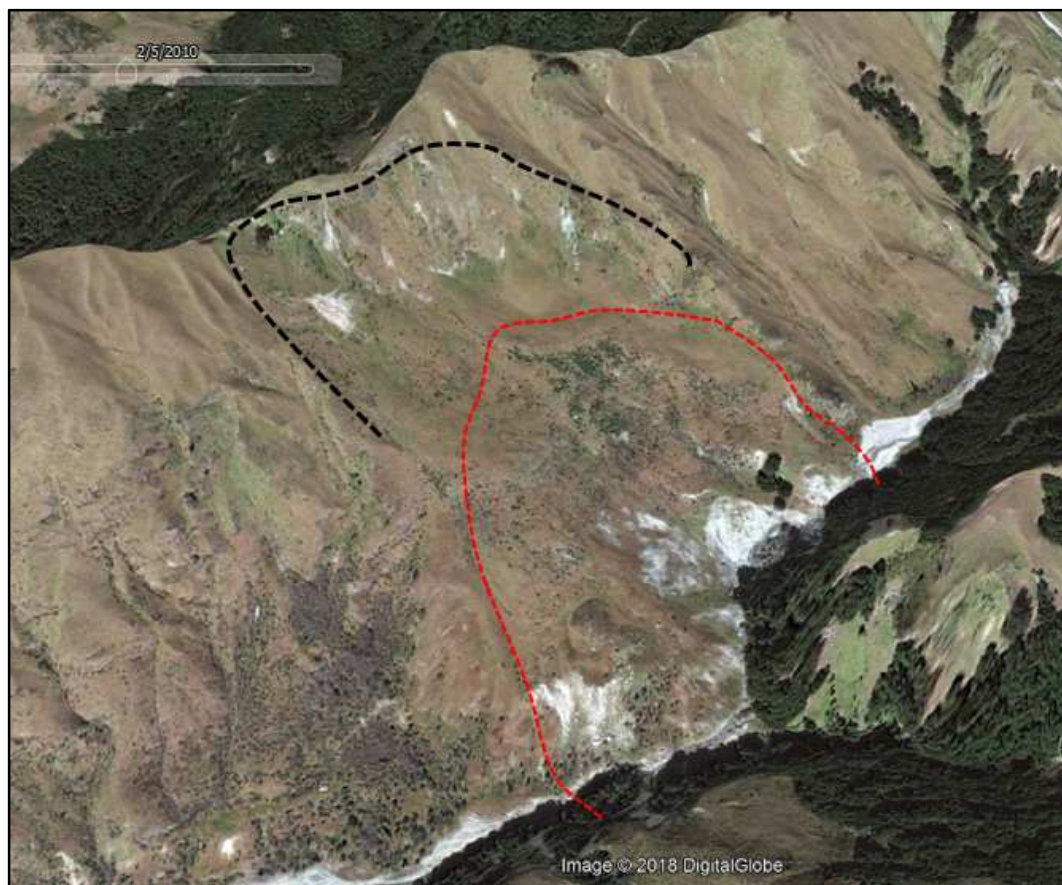
A large landslide up to about 400 m in width, blocking creek and forming the alluvial flat 'Caspers Flat' upstream. The landslide area has a well-defined scarp and hummocky terrain showing landslide deposit, but any landslide dam remnants are indistinct and partially obscured by vegetation on N side of valley.

**Figure 16:** Possible landslide dam in Skippers Creek North Branch. The alluvial flat immediately upstream is Caspers Flat.

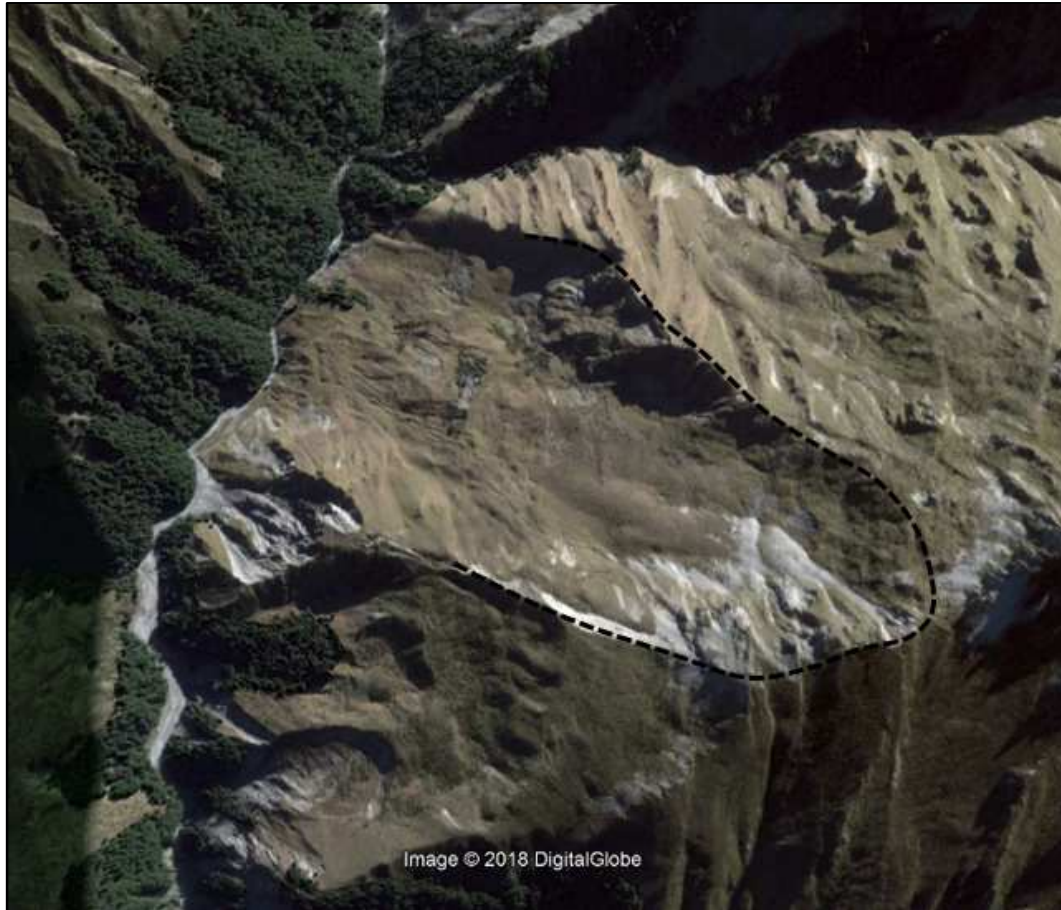
A well-defined landslide scarp ~400 m in width, the creek appears to be incised into possible landslide dam debris at toe of slope, although this is indistinct and obscured by vegetation on the opposite side of the channel.

**Figure 17:** Upper Stony Creek landslide dam.

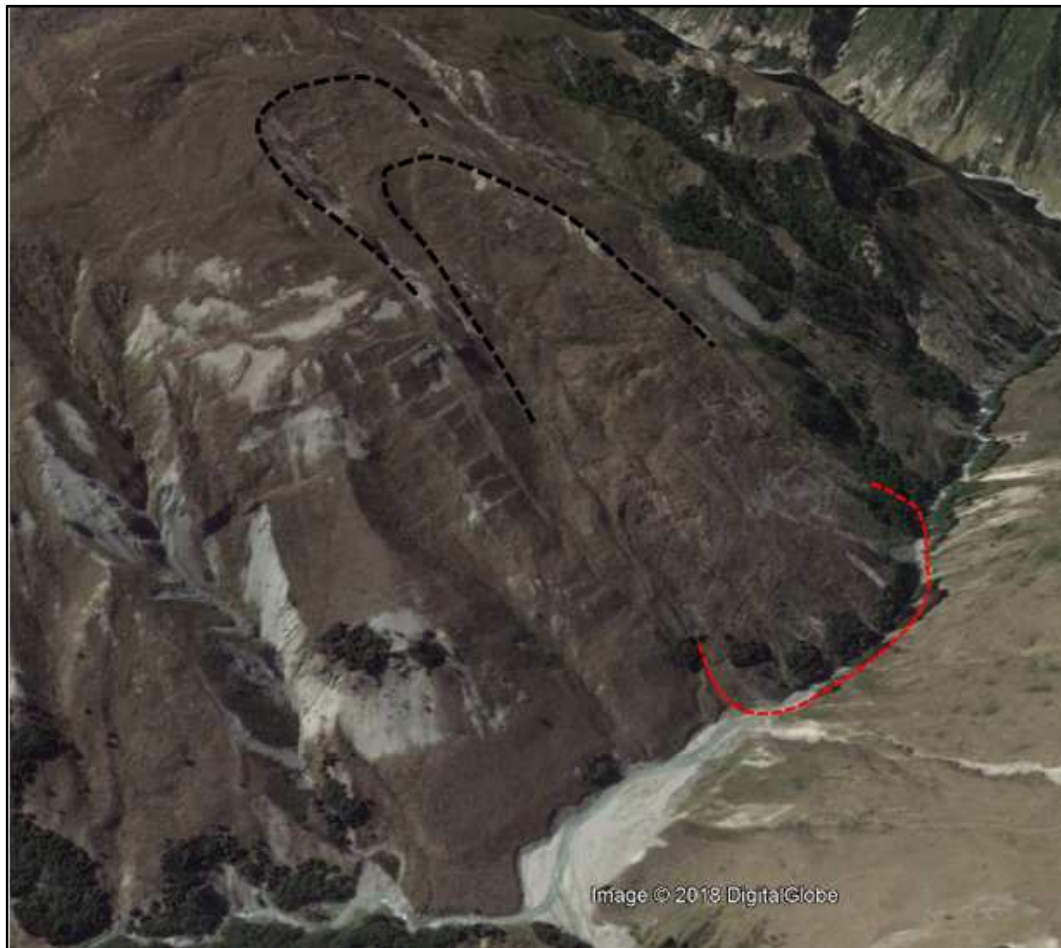
A large landslide ~300 m in width, constricting the creek and forming an alluvial flat immediately upstream. Around 1800 m upstream is an even larger, but poorly defined possible landslide(s) from the northern slopes, where the creek has incised into debris and formed alluvial flats.

**Figure 18:** Upper Moonlight Creek landslide dam.

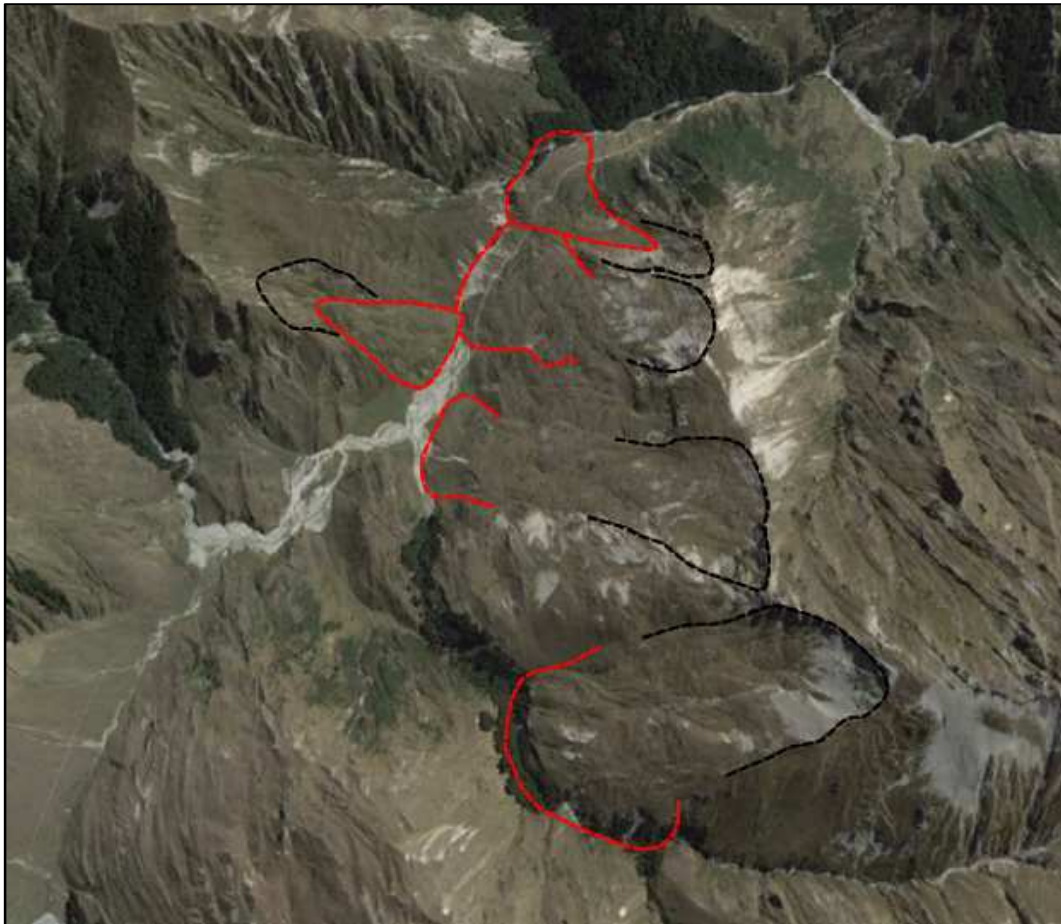
A cluster of large landslides in Luna Creek, a tributary to Moonlight Creek. At least some of these appear to have impacted the creek channel and may have formed landslide dams. These largest of these landslides have areas of 150-250,000 m<sup>2</sup>, with volumes estimated at 3-6M m<sup>3</sup>. The creek has incised a channel estimated at several tens of metres depth into landslide debris forming a steep section of rapids. Upstream for a distance of >1 km is a broad, braided riverbed showing the extensive sediment infilling of valley.

**Figure 19:** A number of large landslides in Luna Creek, some of which may form landslide dams. The stream visible in the upper right of image is Moonlight Creek.

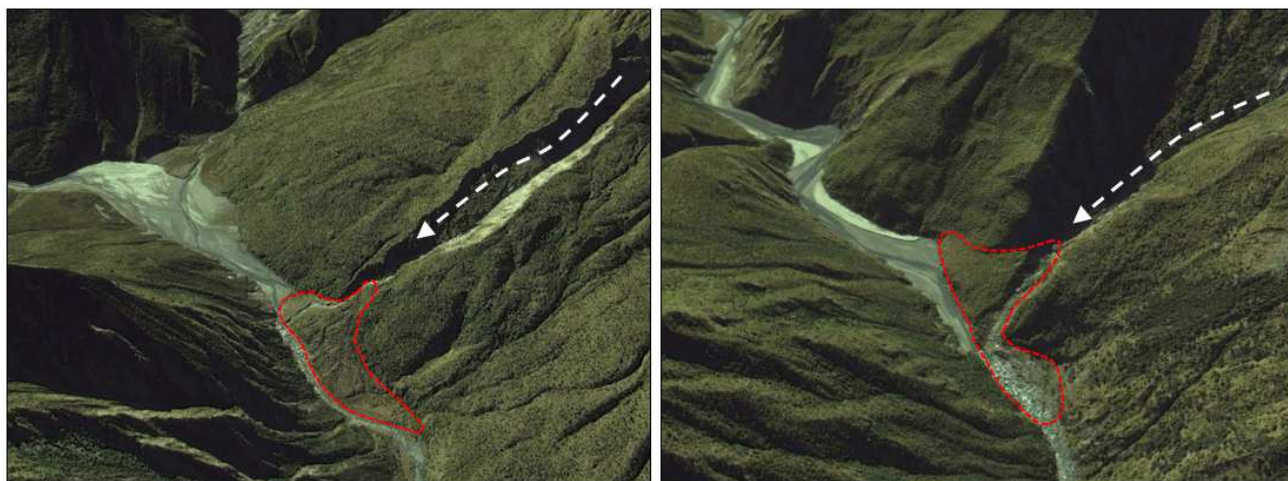
In Shiel Burn are several examples of valley blockages formed by debris flows, with the two most prominent shown below. These both show large debris fans filling the channel at the base of the slope, extending for ~100 m across valley, and >100-200 m along valley. The debris fan deposits have been incised to form a coarse grained boulder section, and shallow gradient alluvial flats are formed upstream.

**Figure 20:** Examples of dam-forming debris flows in Shiel Burn.

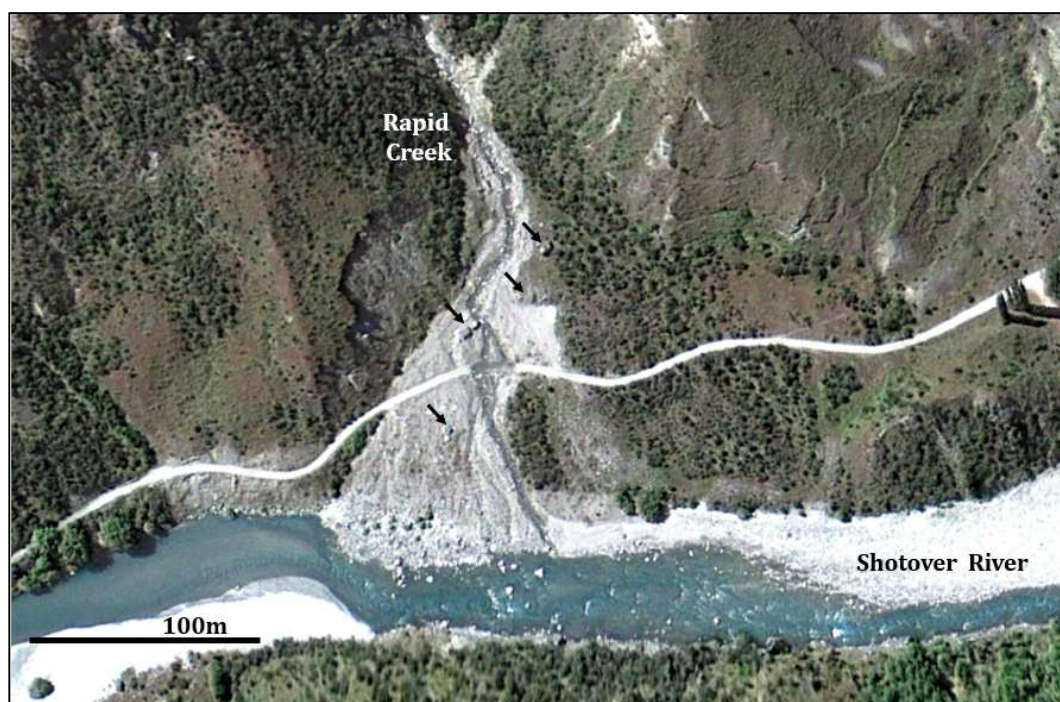
Deposits seen at the Stony Creek (aka Rapid Creek) alluvial fan in the upper Shotover Gorge are interpreted as being that formed by this event. This well-preserved deposit on the alluvial fan intrudes into and constricts the Shotover River channel, and coarse debris can be seen as a train of larger boulders transported downriver from this point. This deposit contains many large boulders up to 4-8 metres in size, both within the inactive vegetated parts of the fan, and within the active stream channel. The bed of this small creek appears to be stripped of vegetation for a distance of >3 km upstream, suggesting formation by a debris flow caused by remobilisation of colluvium from the

*Aerial view of debris flow deposit at Rapid Creek in the upper Shotover Gorge, this contains many large (>4 m) boulders (examples arrowed), and intrudes into the Shotover River channel, with a train of coarse debris being remobilised downstream.*

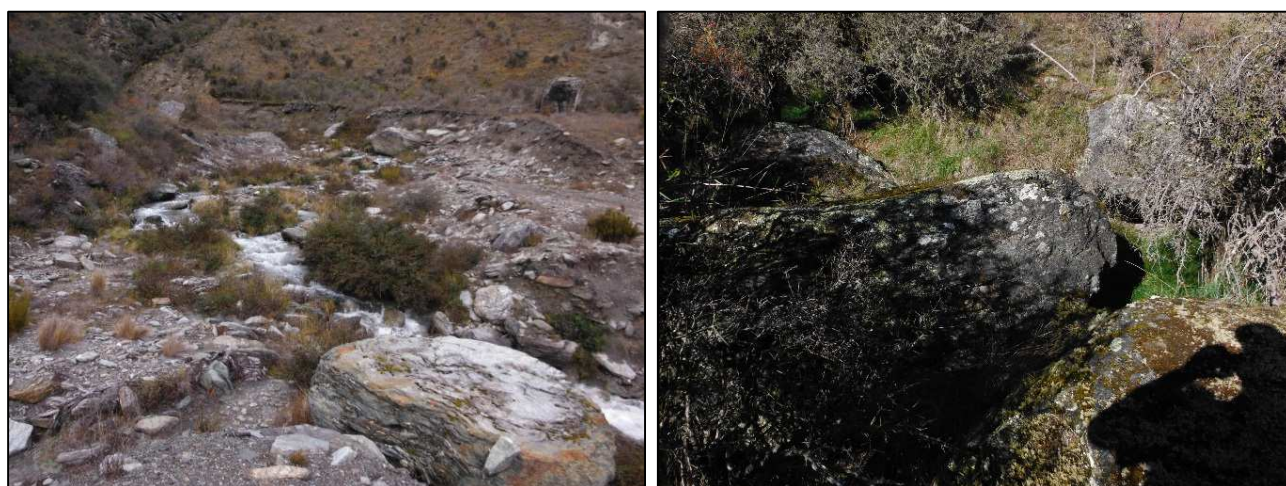
*Debris flow deposit at Rapid Creek. A. Looking upstream from near Branches Road, the boulder in foreground is 4-5 m in size. B. collection of large (>2m boulders) on alluvial fan to the south of the active stream channel.*
